HYDROGEOLOGIC INVESTIGATION

Overburden and Bedrock Site Characterization

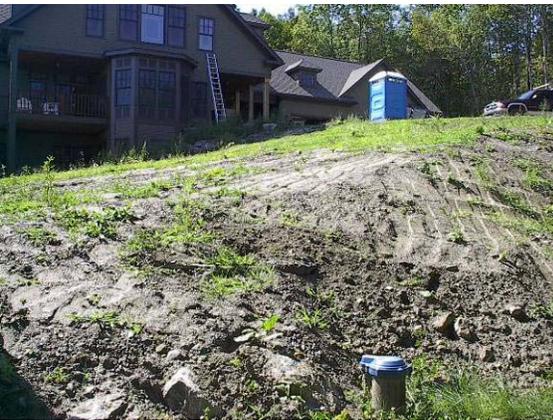
R.E.A. was contacted following the discovery of a fuel oil release during the construction of a new house in Central Vermont. Fuel oil was discovered in the on-site supply well and in the interior plumbing system of the house. **R.E.A.** was able to trace the source of the release to a fuel line that was broken during excavation for a deck footing. During the course of the initial investigation it was noted that bedrock had been blasted to accommodate installation of the building foundation.

Figure 1. Impacted supply well located over 200 feet from the release area.

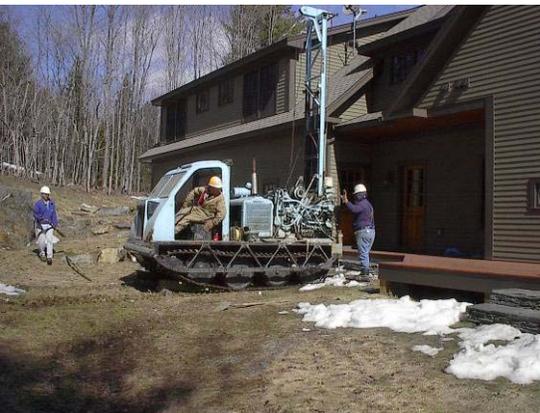
Figure 2. Subsurface Investigation using Track-Rig

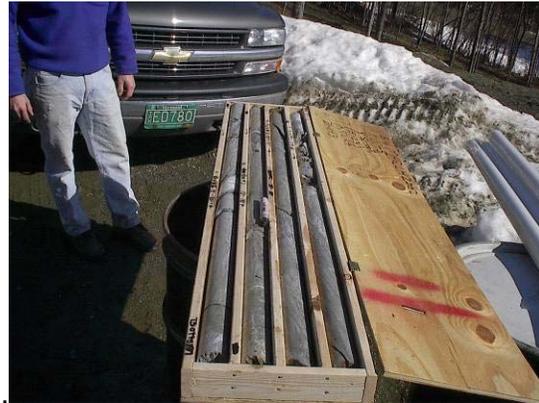
A fracture trace analysis of the bedrock formation revealed an east-west trending fracture zone that was enhanced by the blasting required for the foundation. This data was used to design an effective remediation system and select another on-site location for a new drinking water supply well.

Figure 3 Bedrock Core Samples
